## Jacob Wenner

Project: Solar Variability  
Advisors: Prof. Mike Wagner & Prof. Greg Nellis  
Sponsor: Department of Energy

# Operation's Effect on Solar Receiver Lifetimes

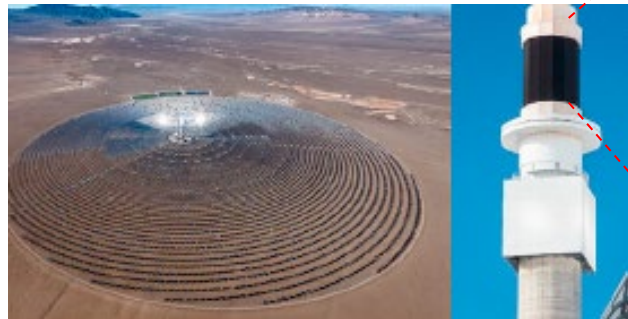
Heliostat field and tower receiver at Crescent Dunes CSP plant [1]

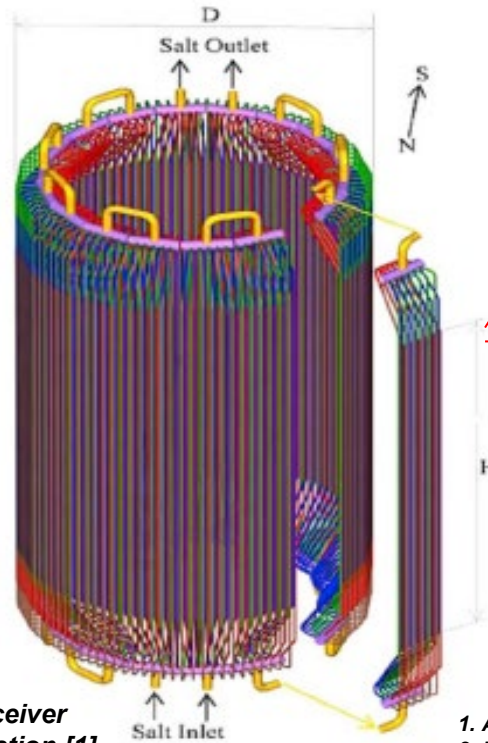
example of solar receiver cylindrical configuration [1]

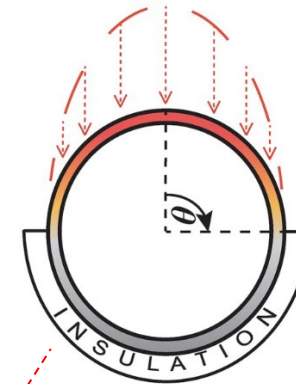
Illustration showing typical tube flux as a function of position. [1]

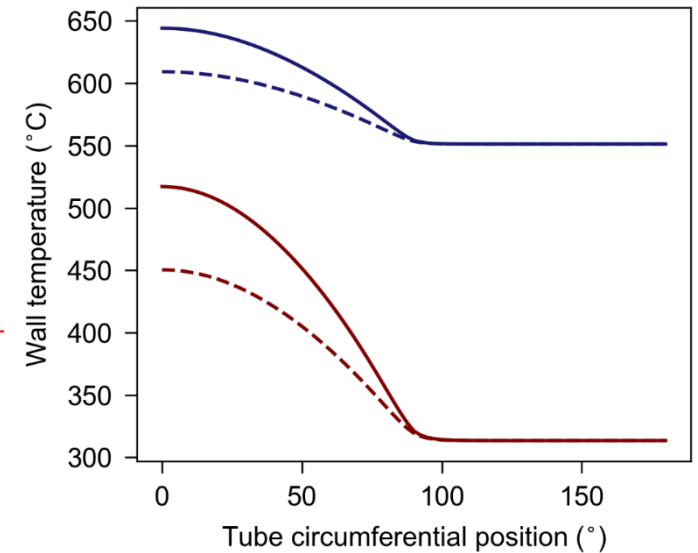
simulated temperature position at  $z=0.5$ , for representative tubes in panel 0 and panel 6 [2]

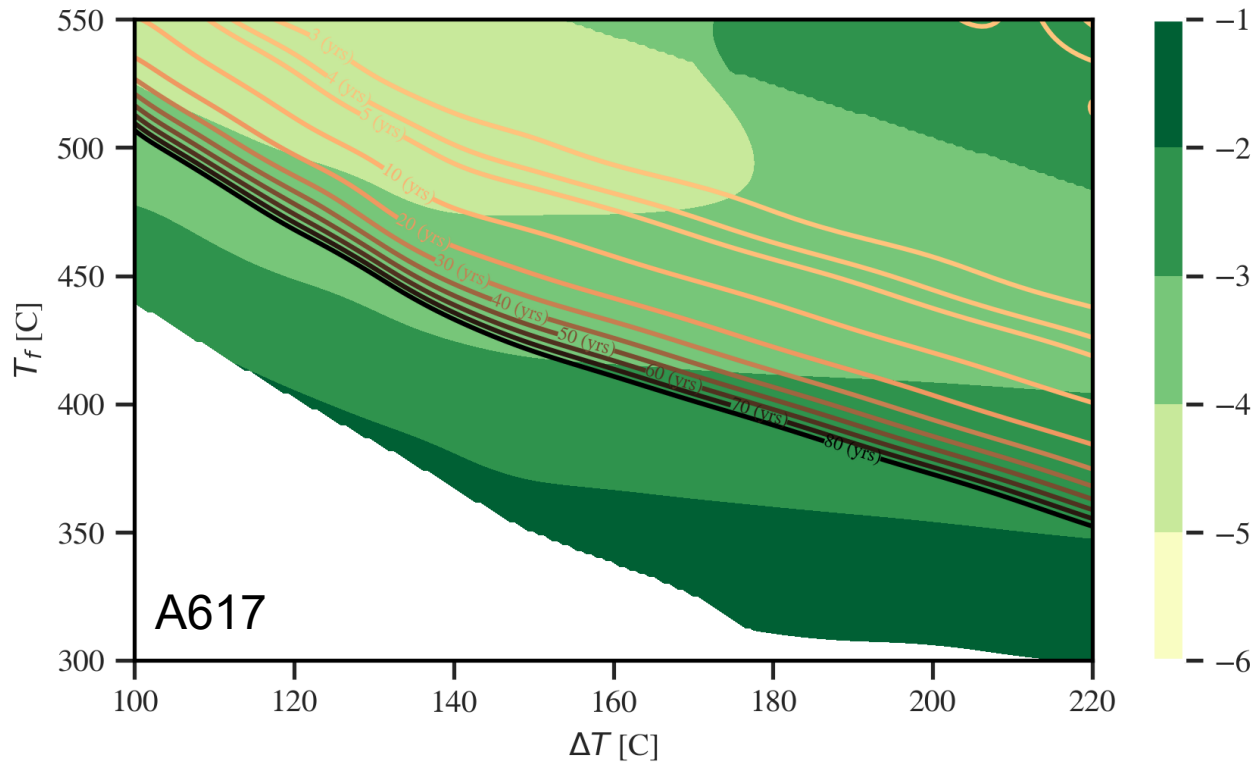
- (above) lifetime contours and cumulative ratios of fatigue to creep damage for A617 material
- For A617 tubes at high  $T_f$  and low  $\Delta T$ , failure occurs due to creep, so cycling is not a concern
- For A617 tubes at medium  $T_f$  and high  $\Delta T$ , fatigue damage could be a risk, so cycling should be avoided

Results are based on FEA thermomechanical simulations in *SRLIFE*

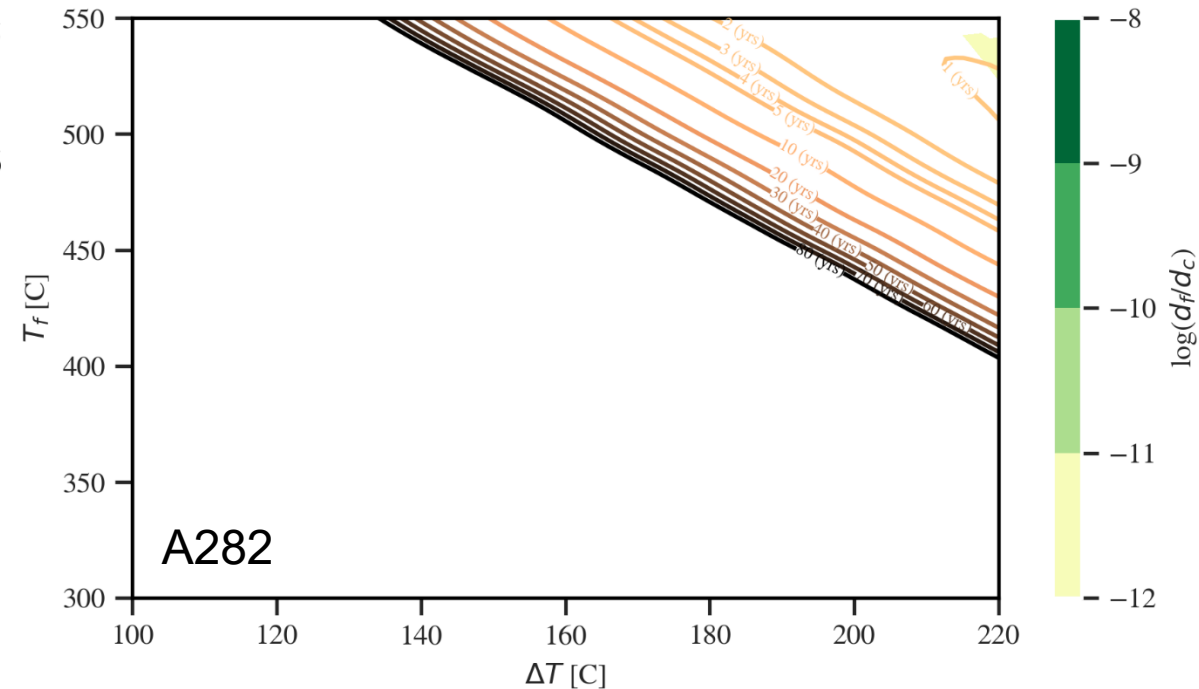
- (below) lifetime contours and cumulative ratios of fatigue to creep damage for A282 material
- All operation regions for A282 clearly predict creep damage to be the dominant cause of failure
